RSRM

Reusable Solid Rocket Motor STS-103 Flight Readiness Review/CoFR

Motor Set RSRM-73

19 November 1999

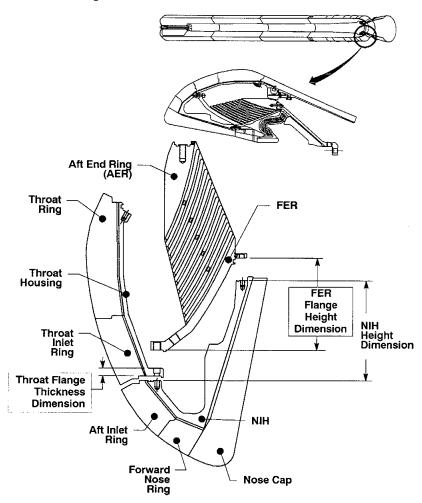
Flange Height Mismatch Worst-Case Tolerance Stackup

RH Forward End Ring (FER)—DR 424500-03

- FER flange-to-flange height of 11.160 in. location violates the criterion of 11.155 in. maximum
- FER flange-to-flange height flag criterion established to control residual stress in phenolic bondlines due to housing flexure
- Detailed assessment of actual FER-to-nose inlet housing (NIH) shows maximum mismatch for this assembly is 0.013 in.
 - Well within allowable ± 0.025-in, mismatch
- Silane primer used on this nose inlet assembly (NIA) bondline results in increased adhesive capability compared to pre-STS-76 NIA bondlines
- Metal/phenolic bonding loads, other bonding parameters, and temperature exposure (storage and transportation) well within family

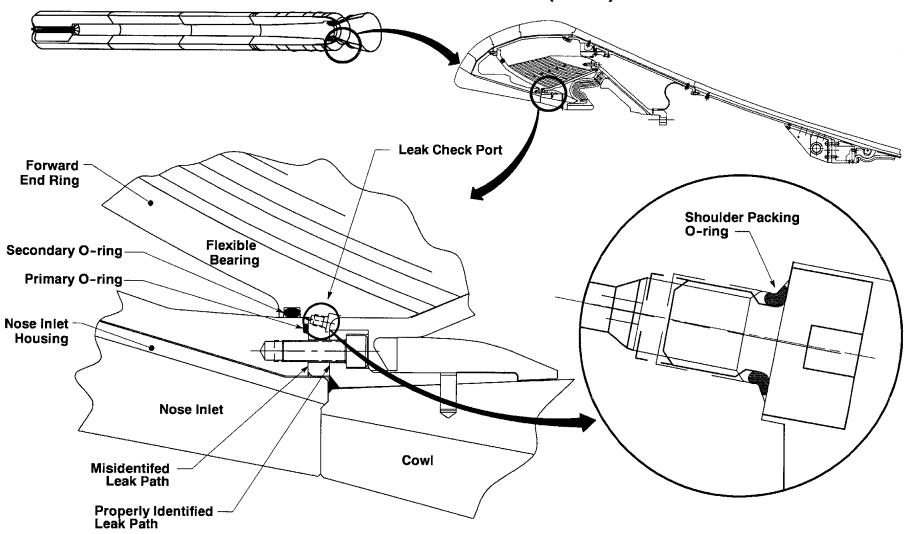
Nose Inlet-to-Forward End Ring Joint Leak Check Port and Plug

Review of the FMEA/CIL document determined that one leak path through RSRM nozzle joint No. 2 had not been properly identified

- The identified joint No. 2 failure mode is not a hardware issue; hardware and processing of joint No. 2 have not changed
- Joint No. 2 design is robust
 - Joint No. 2 has never experienced primary O-ring damage or gas leakage past the primary O-ring or leak check port plug (155 flight and static test motors)
 - Postflight evaluations typically show gas paths in the RTV
 - Postflight inspections verify no heat-affected paint in the forward end ring-to-cowl gap (thus validating analysis that gap region is thermally benign)
 - RTV gas paths and the joint configuration do not preclude pressurization of leak check plug/region

- Leak check port plug uses highly reliable shoulder packing seal under high compression
- Testing (both directions) confirms plug will function and O-ring will seal under extremely adverse conditions
 - Plug seals with through-cut in O-ring, groove through threads, finger-tight torque, and maximum (0.003 in) standoff
 - Plug stays seated with less than 1 in.-lb torque and NSTS 07700 vibrational loads
- Joint No. 2 inspection process ensures that the leak check port plug is properly installed, torqued, and seated
- Failure of the leak check port plug seal would not result in loss of flight or mission
 - Both the primary O-ring and leak check port plug are redundant with the secondary O-ring
 - Conservative thermal analysis indicates no challenge to secondary seal integrity due to gas leakage through plug
 - No credible scenario for joint seal failure

- Postflight inspection shows that the joint No. 2 design is robust with no leakage past the primary seals
- Joint No. 2 inspection process ensures that the leak check port plug is installed and properly seated
- Testing in both directions confirms no leakage past primary O-ring seal under extreme adverse conditions
- Analysis confirm that failure of the leak check port plug seal would not result in loss of flight or mission
- STS-103 is safe to fly
